Pollution prevention case studies

Improvements in the cleaning system: the CIP system (cleaning in place)

Big Drum Ibérica, SA (Reus, Spain)

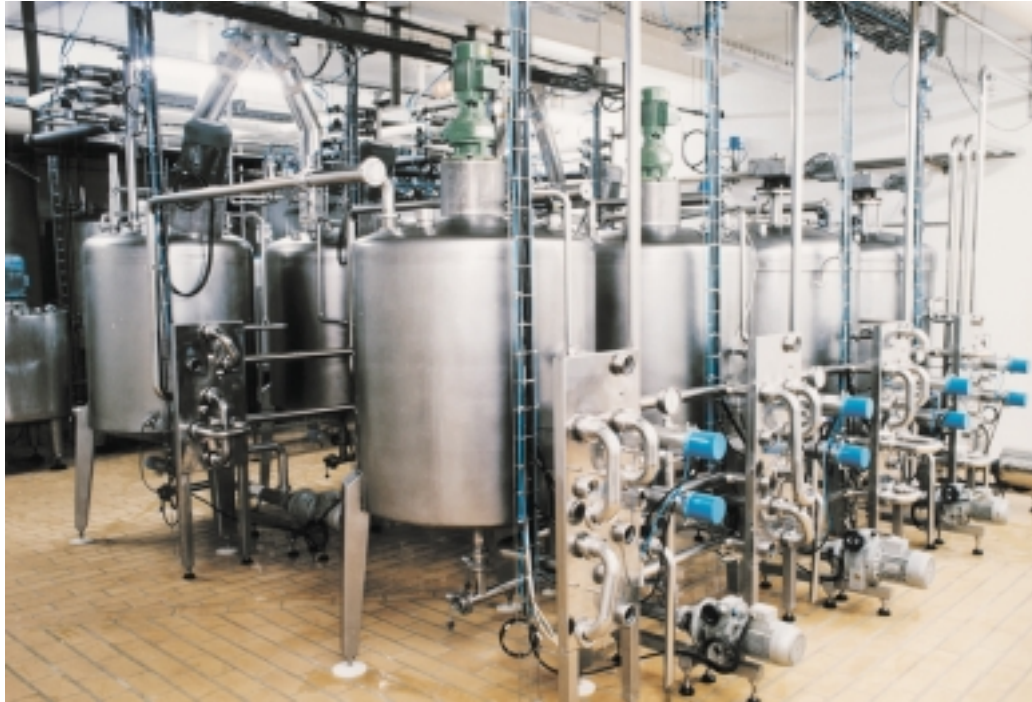
Photography of the installation

Cleaning system

The CIP is based on the following phases:

- Dry-cleaning of the pipes, by means of making a piston go through them impelled by compressed air, so that the batter is recovered.
- Rinsing with water, to drag out the batter remains of the pipe.
- Recirculating a basic solution, to de-scale and to sanitize the pipes.
- Final washing with clean water.

The use of this system has been accompanied by the construction of a recovery batter tank and by the construction of pipes of transport free of obstacles.
